Summary of Massachusetts Wetland Restoration Projects Completed in 2001

April 2002

Wetlands Restoration Program
Executive Office of Environmental Affairs

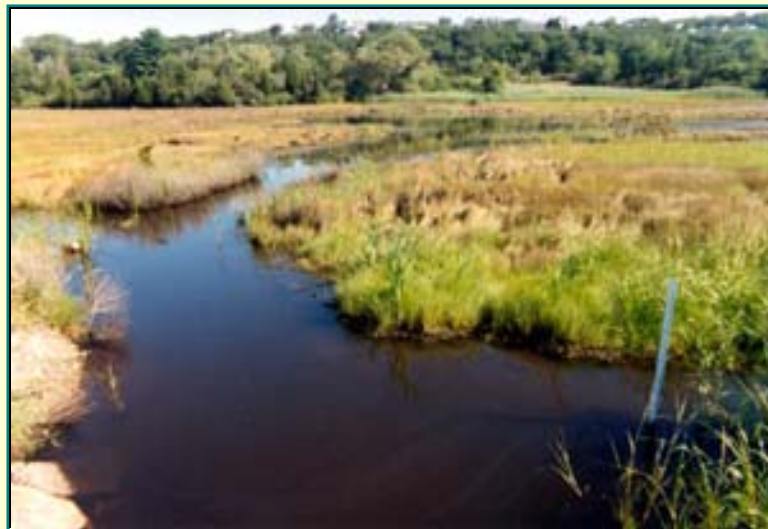
Little Neck Salt Marsh impounding freshwater upstream of collapsed culvert

Site Description: This six-acre marsh is part of the Parker River/Essex Bay Area of Critical Environmental Concern (also known as the Great Marsh) and is located in the Town of Ipswich. Little Neck Road restricted tidal flow to the marsh for decades. The situation was made worse when a culvert under the road collapsed, completely eliminating tidal flow. The salt marsh was essentially a brackish pond, as freshwater drainage was impeded by the blockage. Coverage of *Phragmites* increased, displacing native salt marsh vegetation.

Restoration Work Performed: With guidance and support from MWRP, the Ipswich Department of Public Works replaced the old 24-inch culvert with two four-foot wide arch culverts in May 2001, restoring tidal flushing into and out of the impaired marsh. The Natural Resources Conservation Service provided design and engineering services.

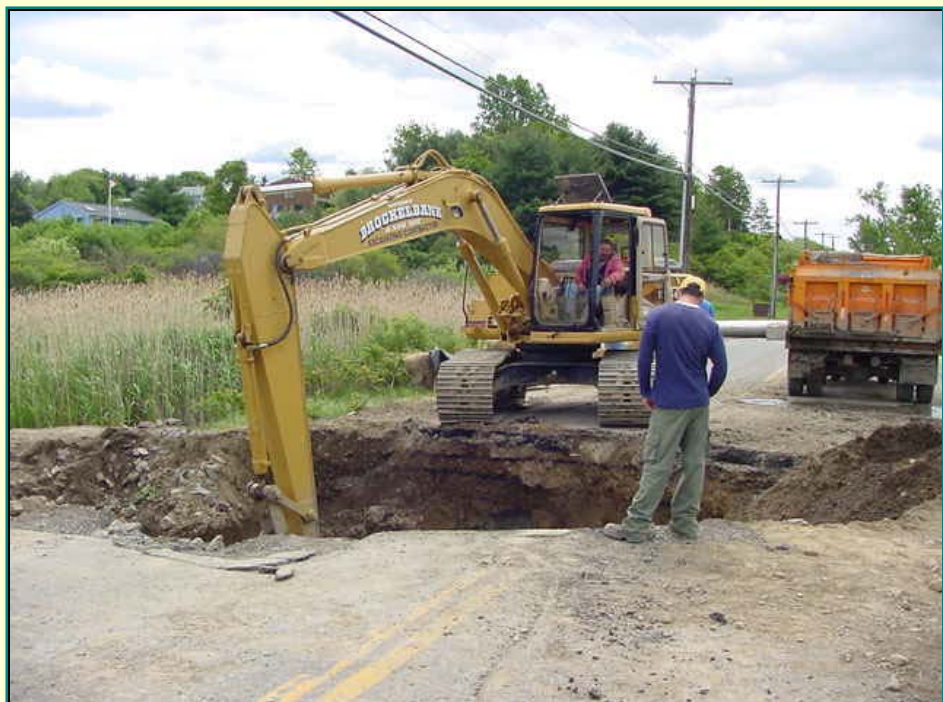
Breaking Ground at Little Neck Road Restoration Site

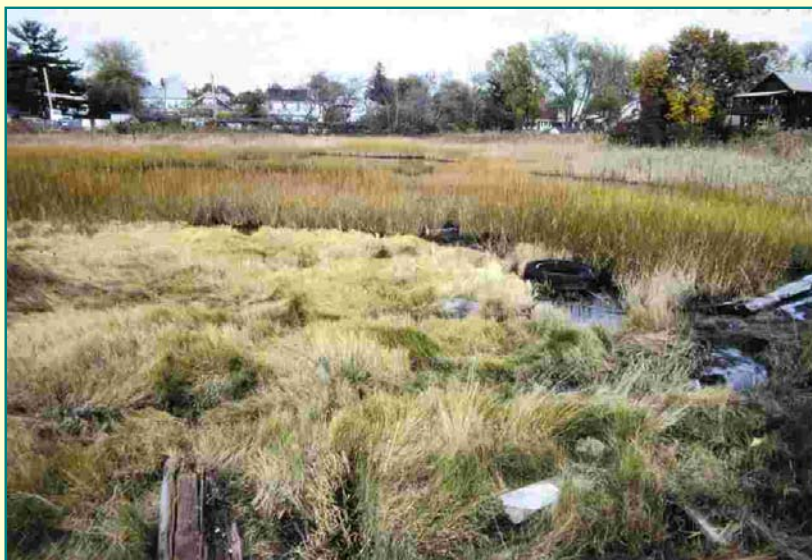
Fisherman's Bend salt marsh prior to restoration work

Site Description: This eight-acre salt marsh is located in the Town of Winthrop. Two crossings of the marsh (an abandoned sewer line and a walking path) restricted tidal flows to the marsh and obstructed fresh water runoff from leaving the marsh surface. As a result, large areas of the marsh were colonized by common reed (*Phragmites australis*), and the marsh developed a serious mosquito breeding problem. In addition, the marsh was covered with trash, from children's toys to illegally dumped tires and construction debris.

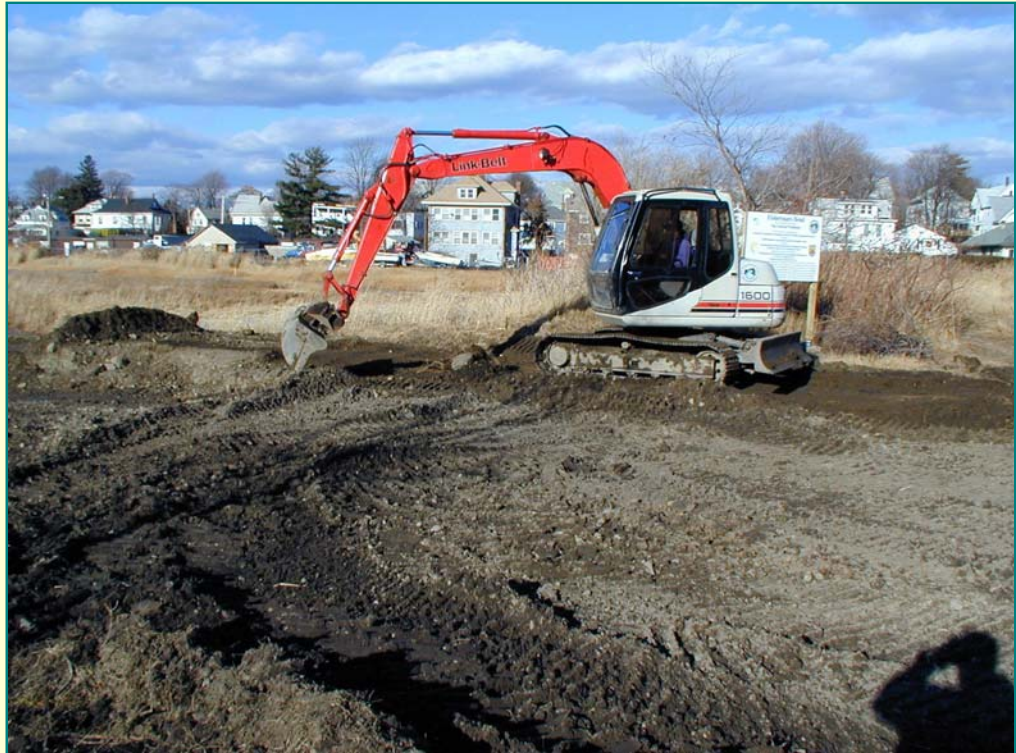
Fisherman's Bend restoration project under construction

Restoration Work Performed: The Town of Winthrop, with guidance and support from MWRP, organized and conducted a marsh clean-up involving dozens of local citizens, the majority of whom live in the vicinity of the marsh. Over 120 cubic yards of rubbish and debris and 70 tires were removed from the marsh. Following site clean up, the Northeast Massachusetts Mosquito Control and Wetlands Management District (NMMCWMD) mowed the *Phragmites*, breached the two tidal restrictions, and excavated perimeter ditches and several pannes on the marsh surface.

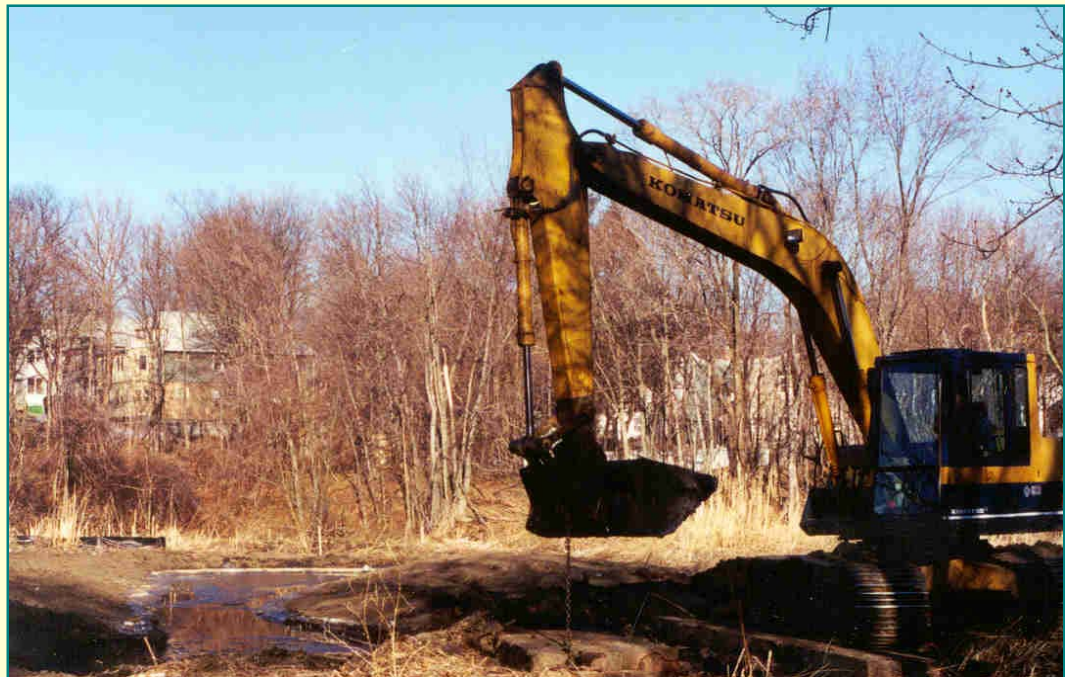
Meadow Brook restoration project under construction

Restoration Work Performed: Restoration work performed at this site included herbiciding the stands of common reed, excavating portions of the marsh to create areas of deep marsh, placing the excavated material on areas of the remaining portions of the marsh to create areas that would support shrub swamp, and planting appropriate vegetation in the various wetland zones. The planting was performed entirely by volunteers, from girl scouts to elected Town officials and state employees.

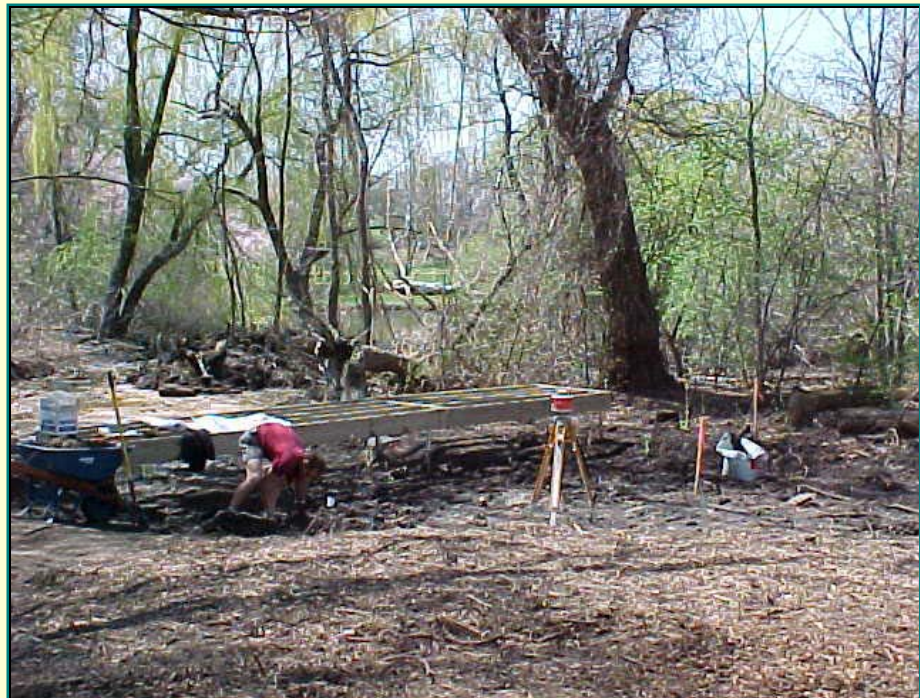
Hall's Pond restoration project under construction

Restoration Work Performed: The Hall's Pond Restoration Project involved the installation of a new stormwater drainage system to control runoff entering and exiting the pond. The system is designed to direct the "first flush" of runoff into a sedimentation forebay, where the majority of sediments are deposited and routinely cleaned out. Water is then directed into the pond and through a newly created fringing marsh. Additional runoff, when present, bypasses the pond through a diversion pipe. This work was completed in 2001. Supplemental planting within the marsh area will continue in 2002. In addition, substantial invasive plant removal and landscaping with native plants was undertaken throughout the upland area surrounding the pond.

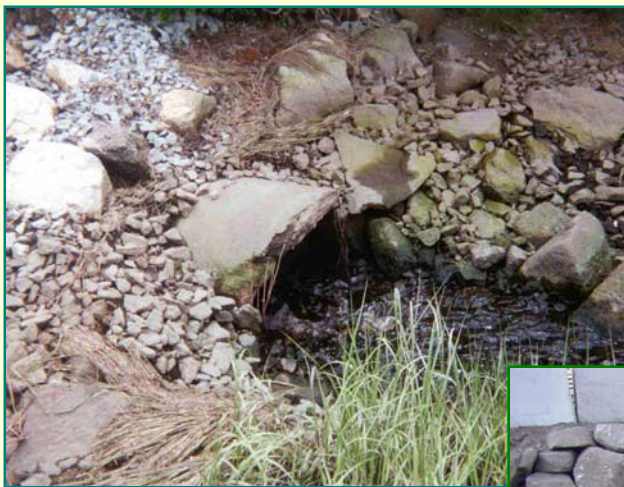
Site Description: The upper six acres of the Hammett's Cove salt marsh is separated from the larger 46-acre Hammett's Cove salt marsh system by Creek Road. Prior to construction, an undersized, 30-inch culvert conveyed tidal flows to the upper reaches of the salt marsh. As a result of this restriction, woody vegetation had begun to encroach on the marsh and common reed replaced much of the diverse high marsh vegetation community.

Old culvert at Hammett's Cove

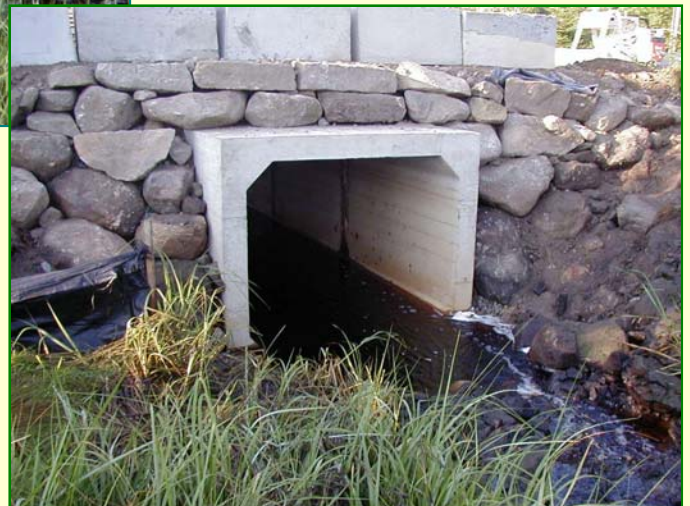
New culvert at Hammett's Cove

Restoration Work Performed: As part of a suite of improvements to Creek Road, including the addition of stormwater basins and repaving, the Town of Marion replaced the tidal restriction with a 4-foot by 4-foot box culvert. The Town also removed some stones from the upgradient stream channel that were impeding tidal flows to the salt marsh.

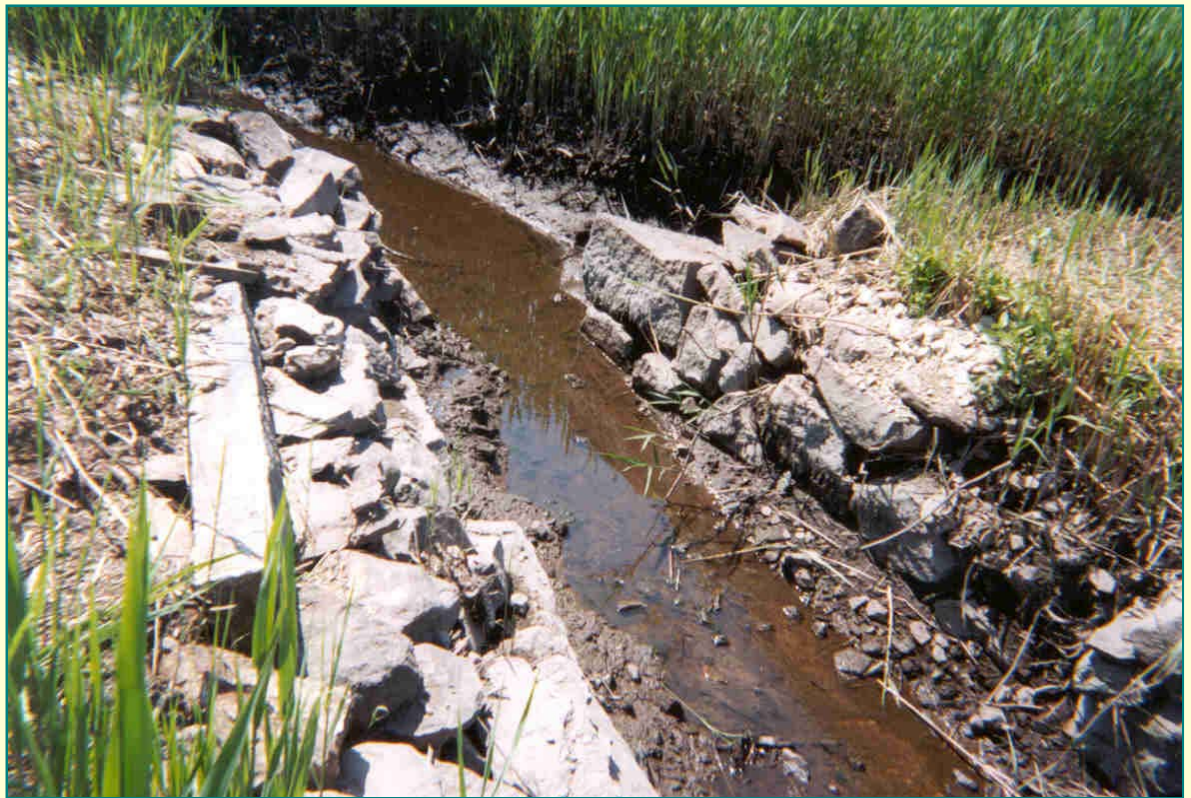
Site Description: This salt marsh bordering the Palmer River in the Town of Swansea is the historic location of the Barneyville Shipyard, a shipyard that constructed clipper ships. Prior to restoration activities, a stone culvert had collapsed in a dike that crosses the marsh, impeding the flow of tidal water to upgradient portions of the marsh. In addition, ditches that conveyed tidal waters to portions of the marsh had filled in and become overgrown with common reed, and extensive stands of common reed were located throughout this 20-acre marsh.

Barneyville Marsh after collapsed culvert was removed

Work Performed: The Bristol County Mosquito Control Project mowed areas of common reed on the marsh, removed portions of the collapsed stone culvert from the dike, and cleaned and unblocked several of the most important ditches on the marsh.

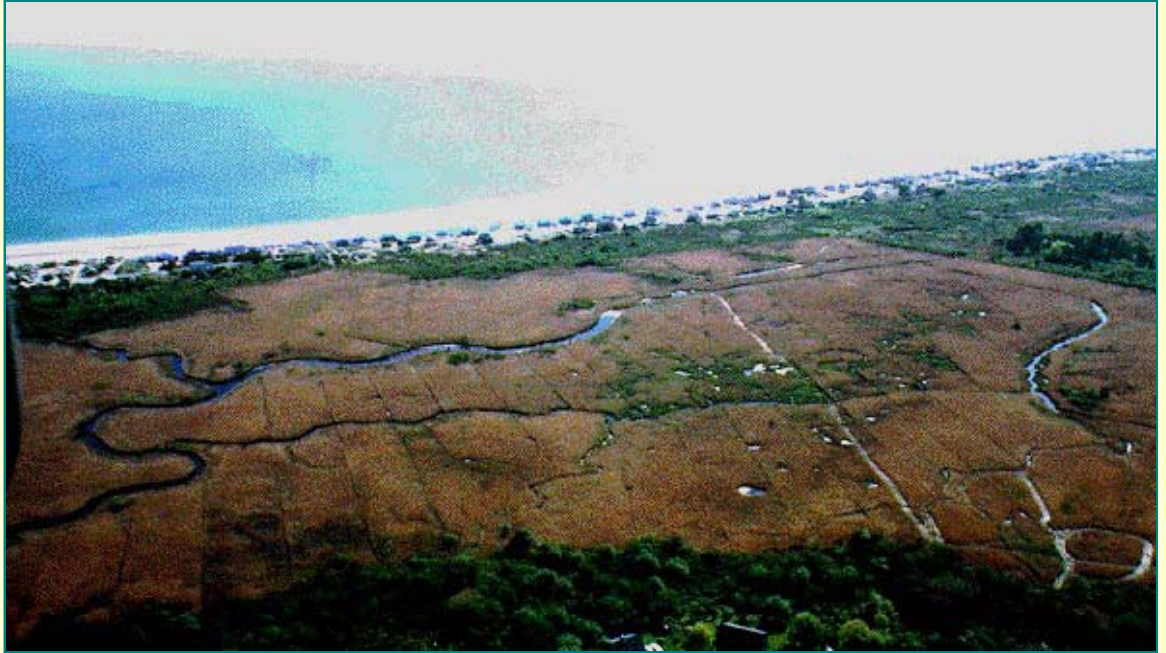
Sagamore Marsh prior to restoration work

Site Description: Reconstruction of the Cape Cod Canal by the Army Corps of Engineers in the 1930s resulted in extensive impacts to the 360-acre Sagamore Marsh. Disposal of excavated and dredged material during construction resulted in filling of approximately 175 acres at the southern end of the marsh that became separated by a dike from the rest of the marsh. Dredged material in the diked area, along with the accretion of littoral material north of the Canal jetties, closed the tidal inlet from Cape Cod Bay into Sagamore Marsh. A 48-inch culvert was constructed to drain the marsh into the Canal. The culvert has restricted tidal flow over the past 70 years resulting in vast areas of *Phragmites*-dominated marsh.

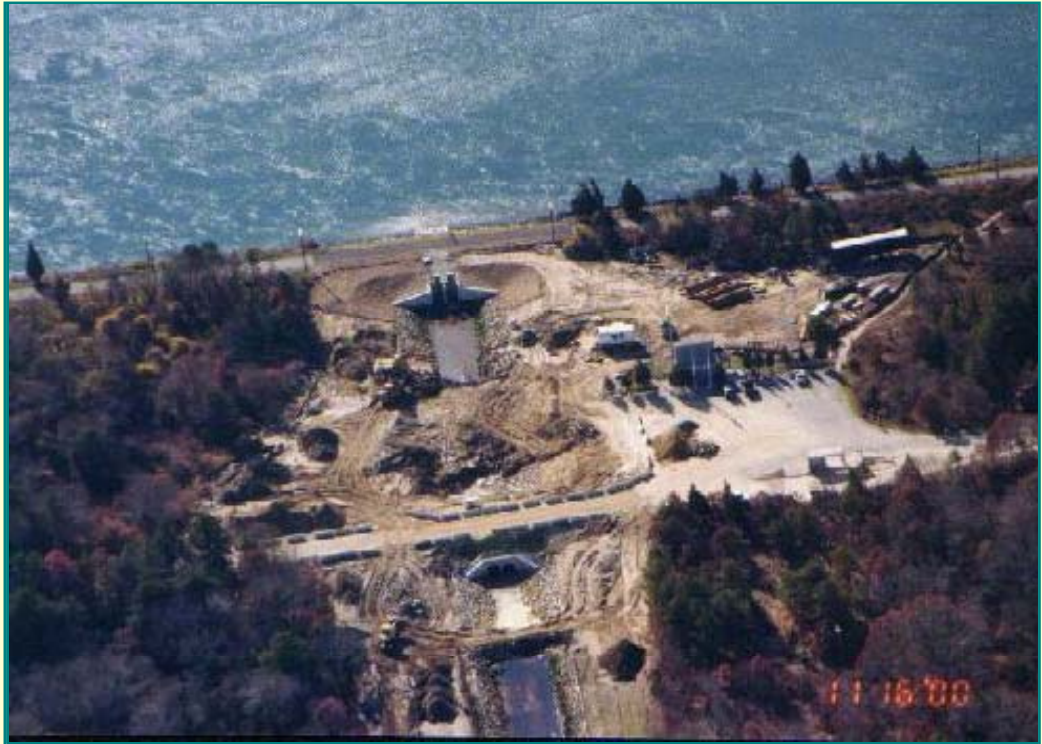
Sagamore Marsh during construction

Restoration Work Performed: The US Army Corps of Engineers, in partnership with the Massachusetts Department of Environmental Management and MWRP, replaced the existing degraded 48-inch diameter reinforced concrete culverts beneath the Scusset Beach and the Cape Cod Canal service roads with two 6-foot high by 6-foot wide reinforced concrete box culverts, installed electric sluice gates for primary flow control with manual backup flow control at the gates, deepened the man-made channel which extends 1,100 feet north into the marsh from the canal, and widened the man-made channel from an existing bottom width of 4-feet to 12-feet. In order to avoid flooding impacts to adjacent homes, only 50 acres of the 175-acre site will be restored to full tidal flushing.
